Situation Photo Log

Thursday, February 21, 2013

Kalamazoo River / Enbridge Spill

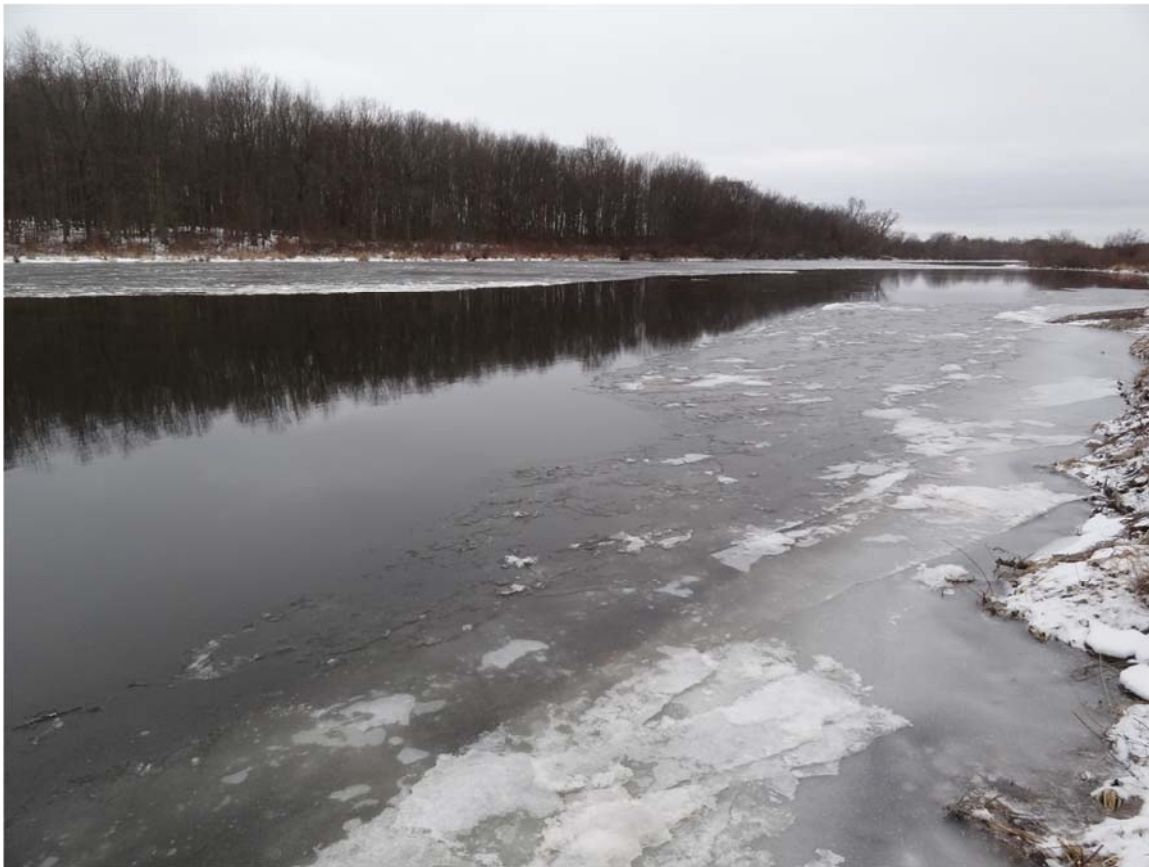
1. C0.4 Boat launch river icing conditions observed.

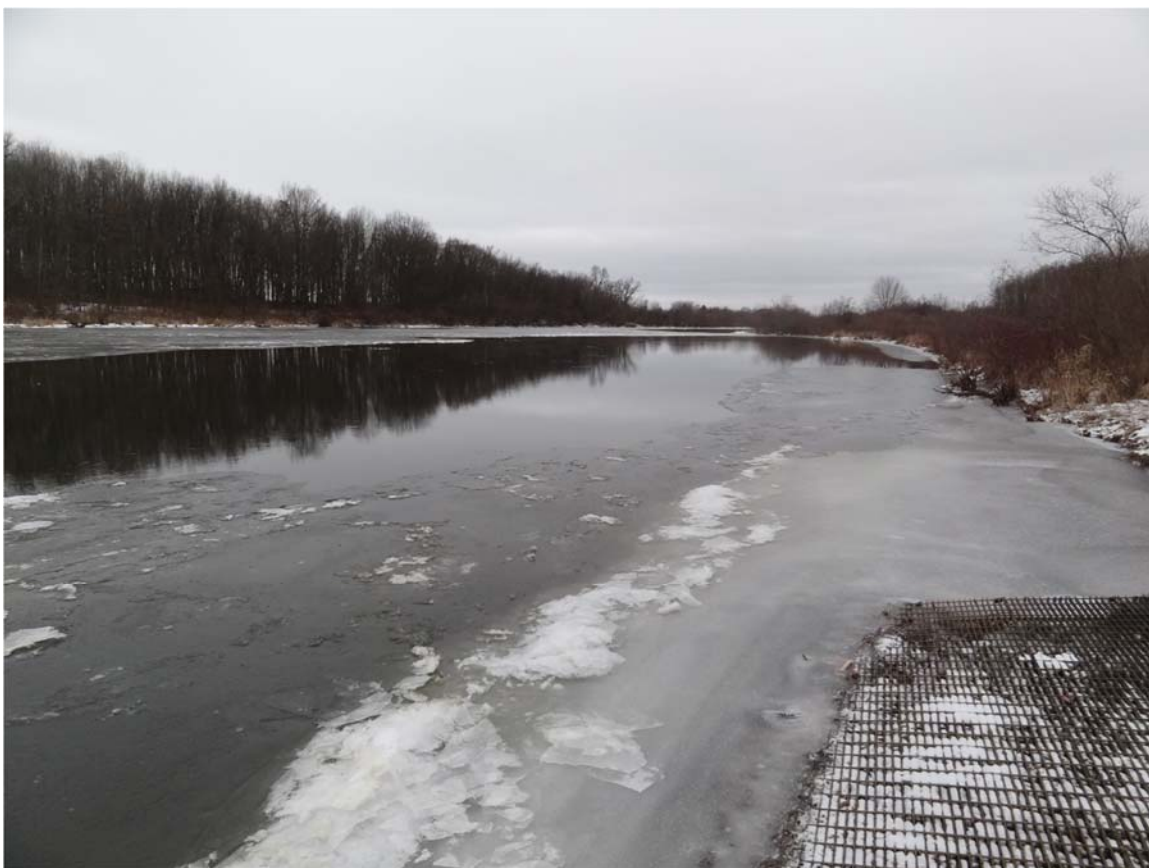
2. C0.4 Boat launch river icing conditions observed.

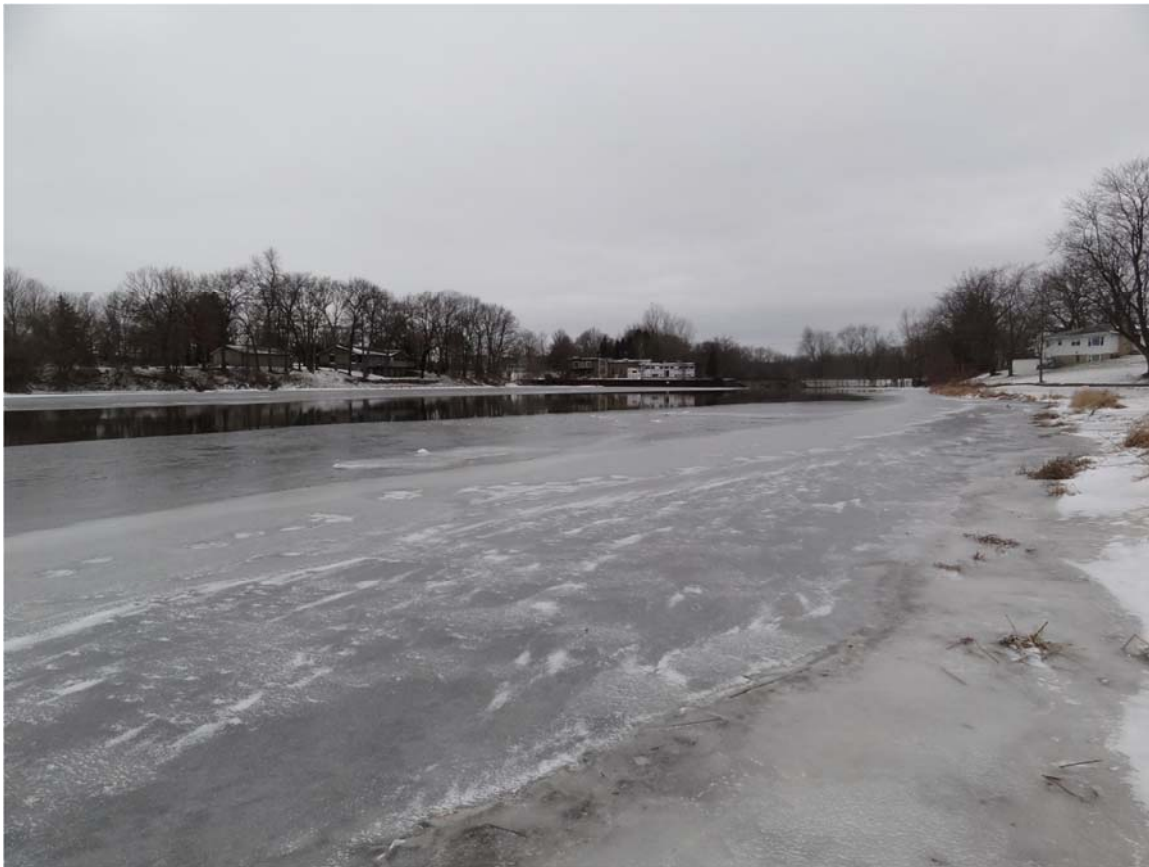
3. MP5.75 Ceresco Dam impoundment river icing conditions observed.

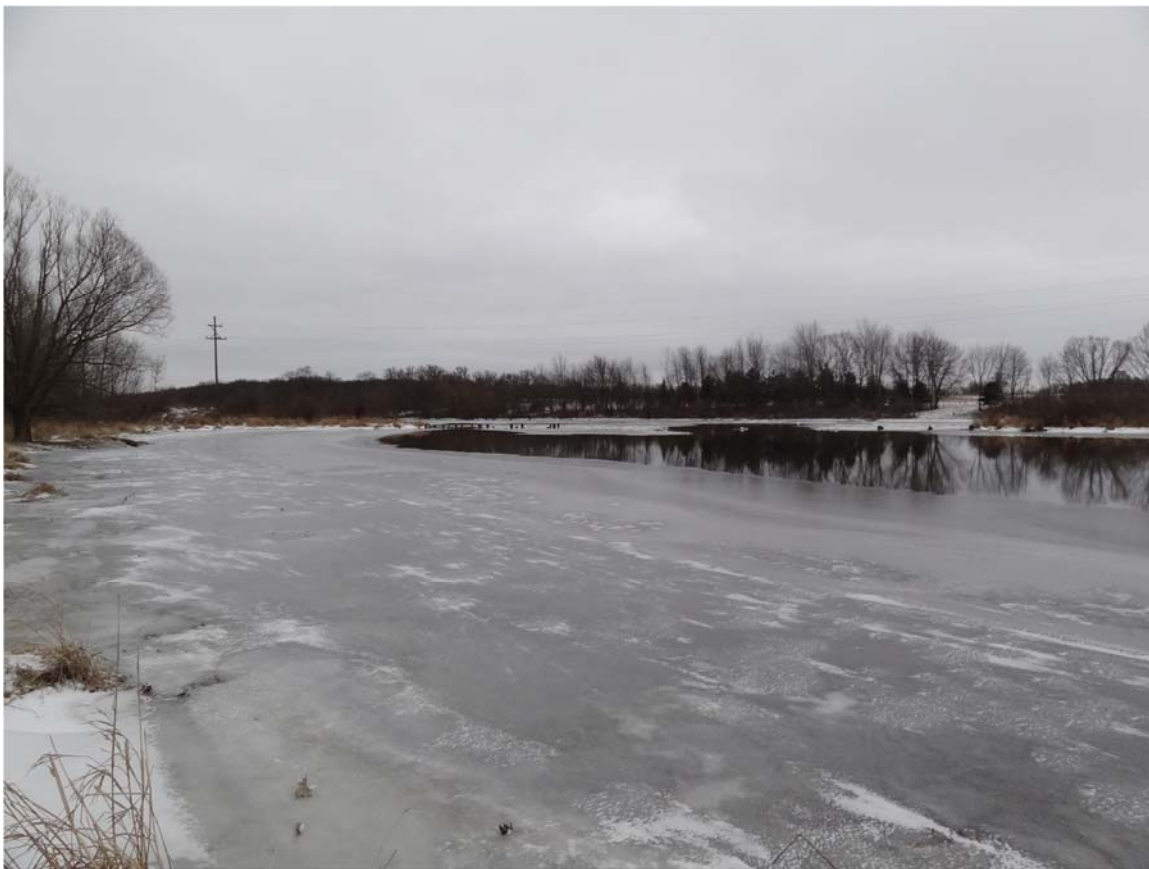
4. MP5.63 Ceresco Dam impoundment river icing conditions observed.

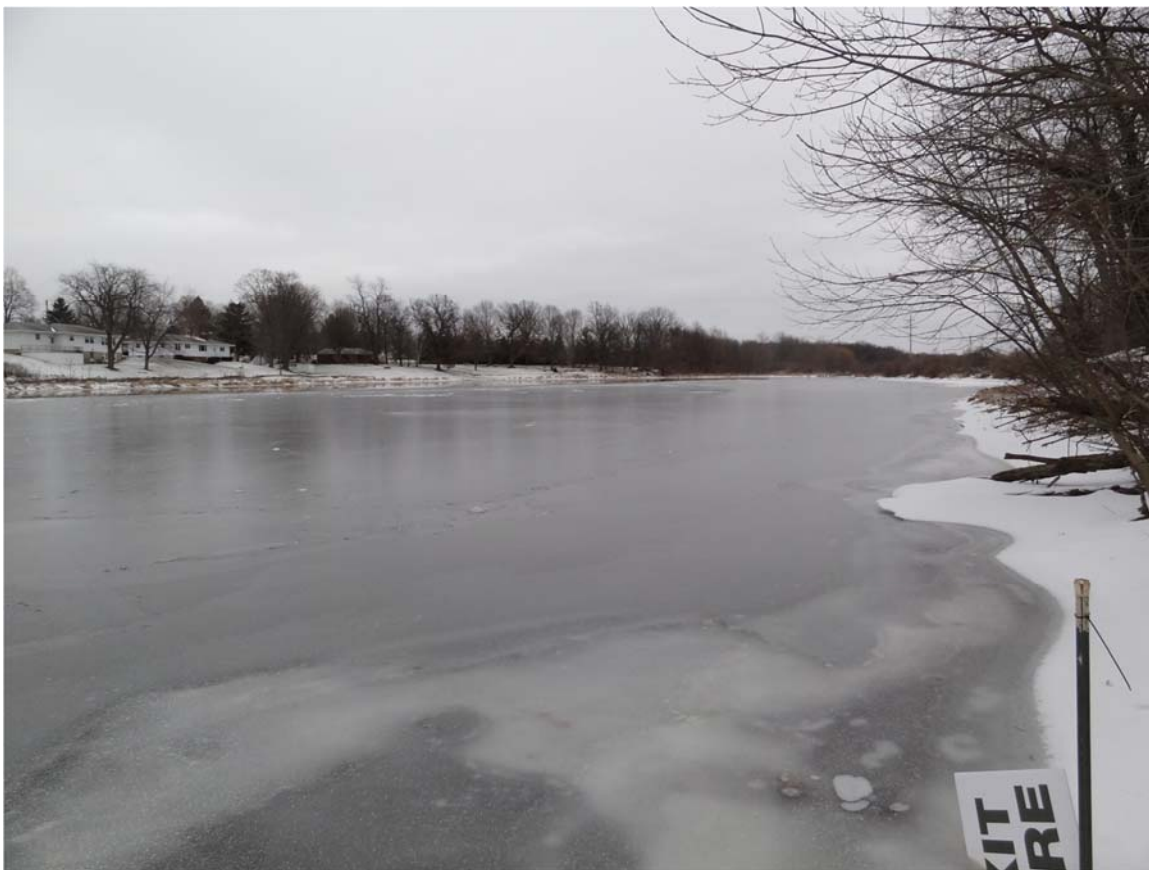
5. Ceresco Dam impoundment river icing conditions observed.

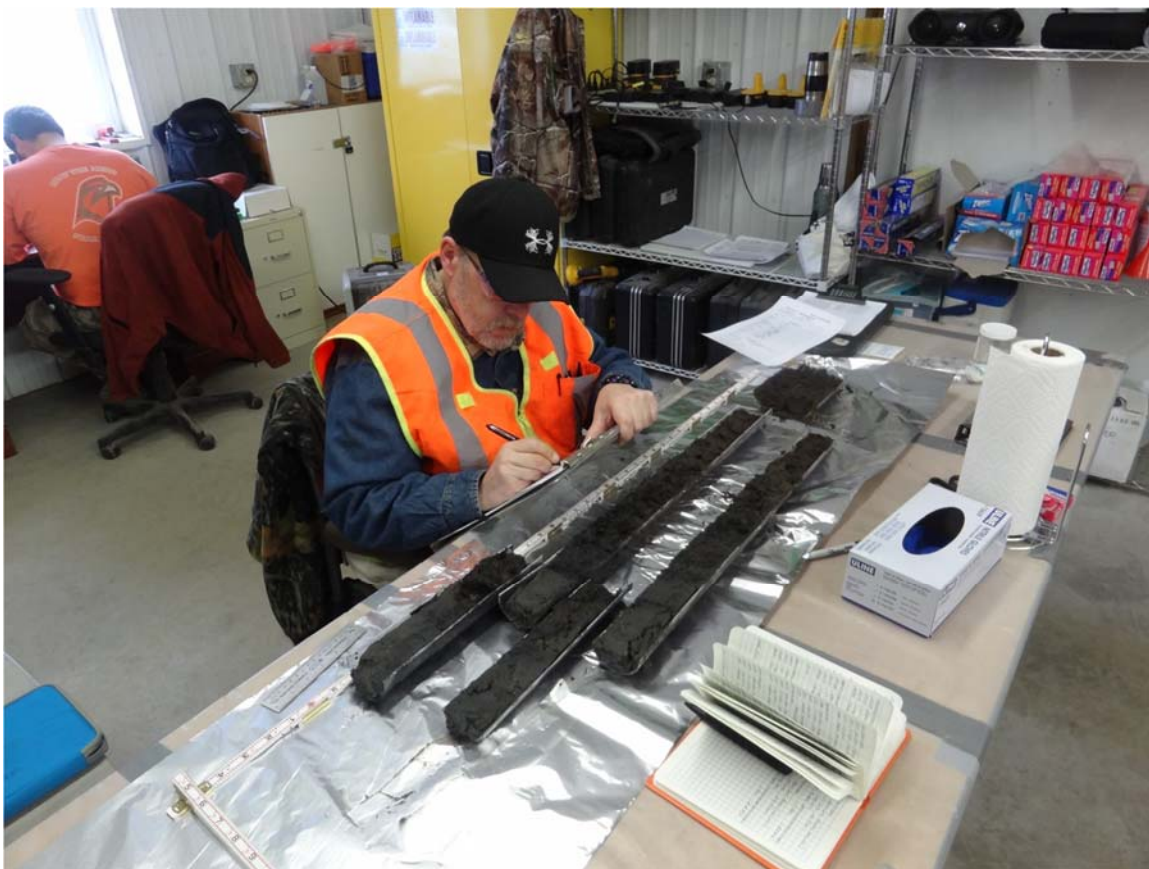
6. C3.2 Pole Barn observed core logging.

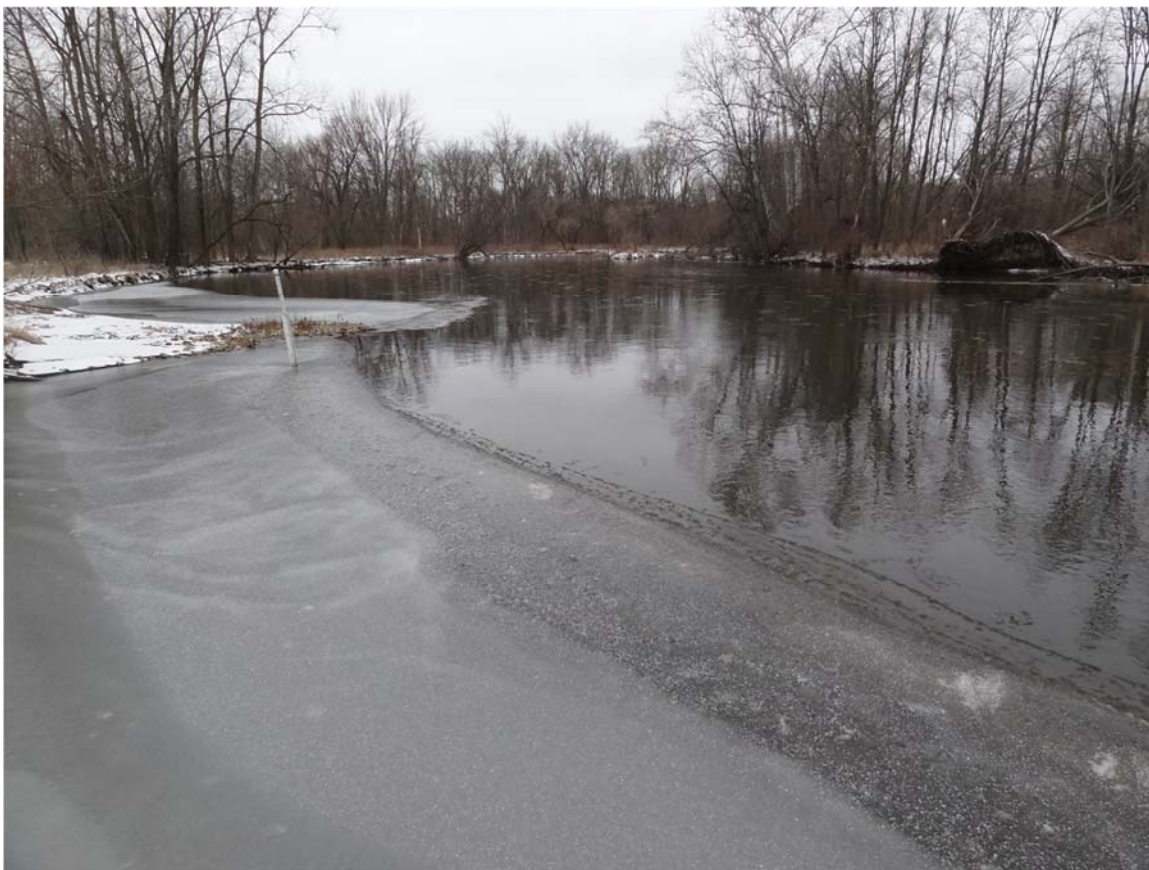
7. C3.2 Observed river icing conditions.

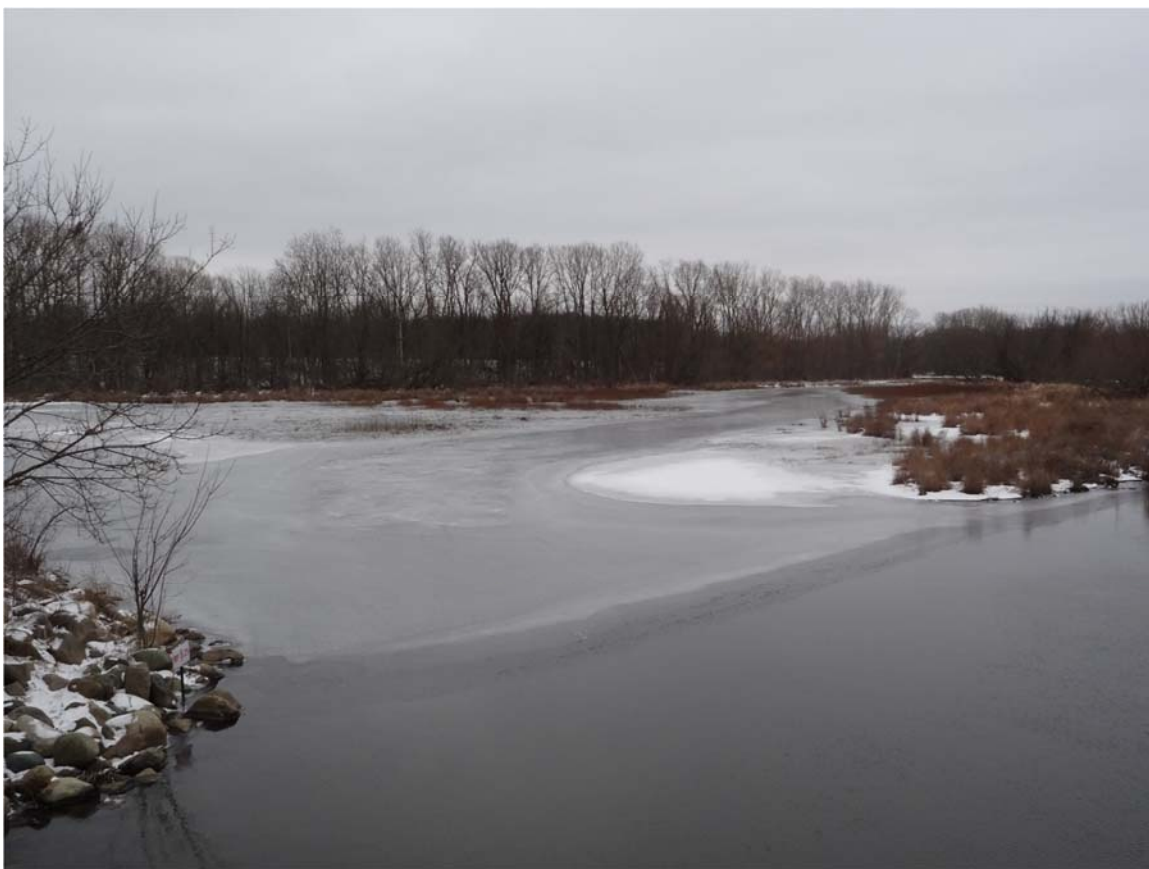
8. MP15.25 South Mill Pond river icing conditions observed.

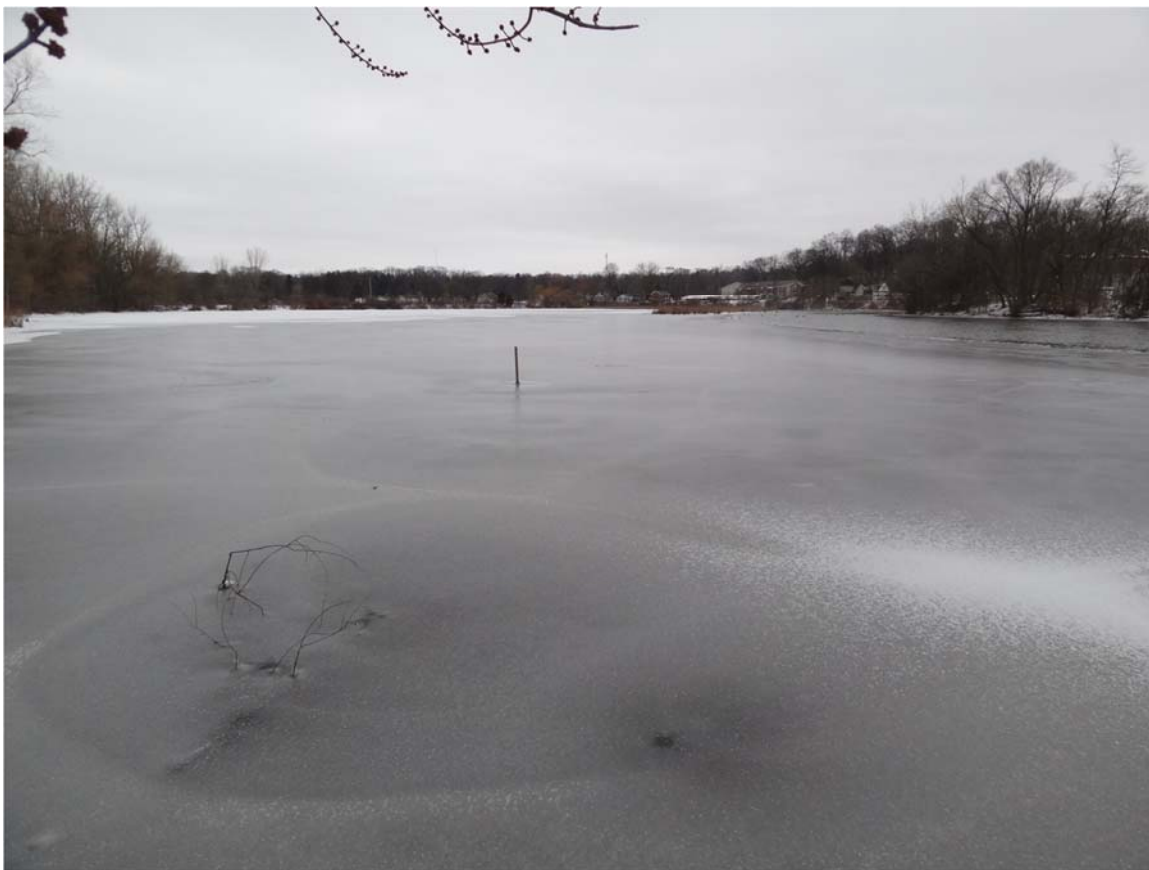
9. MP15.75 North Mill Pond river icing conditions observed.

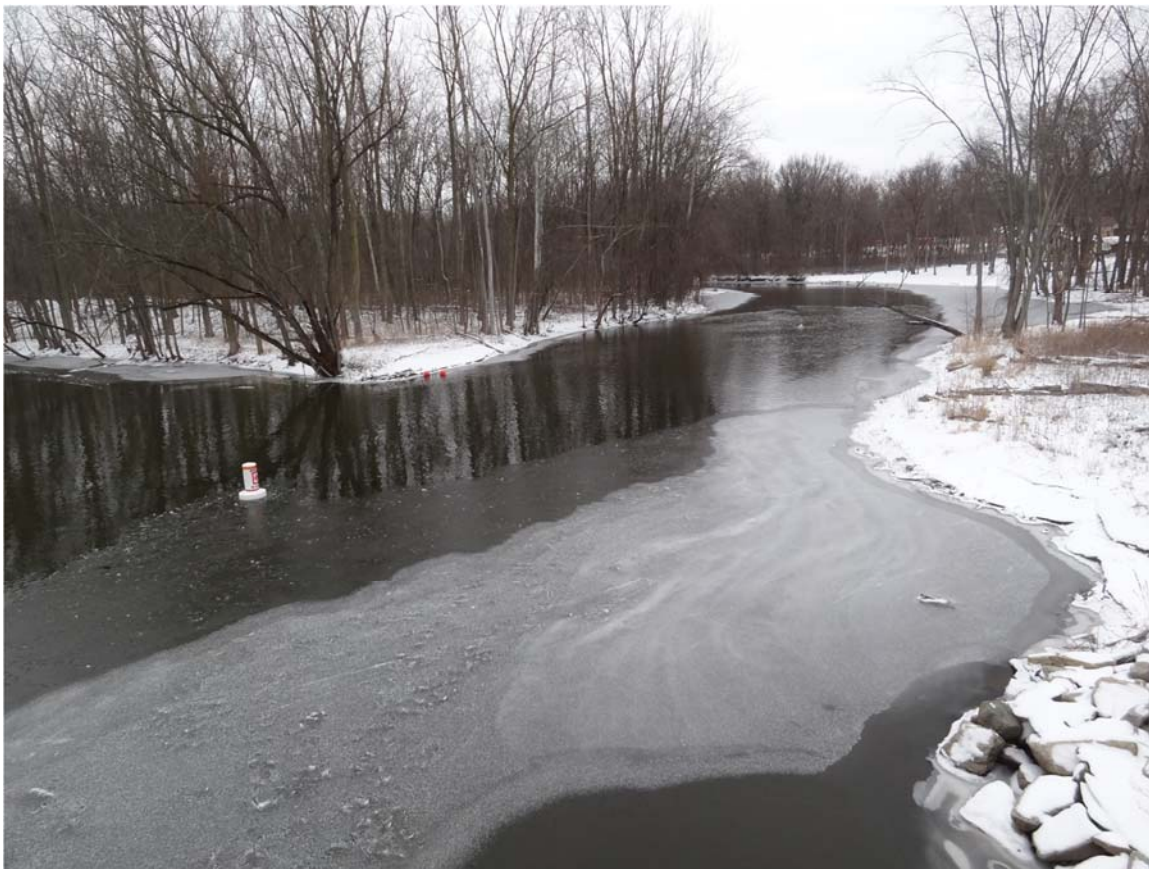
10. MP21.5 River icing conditions observed.

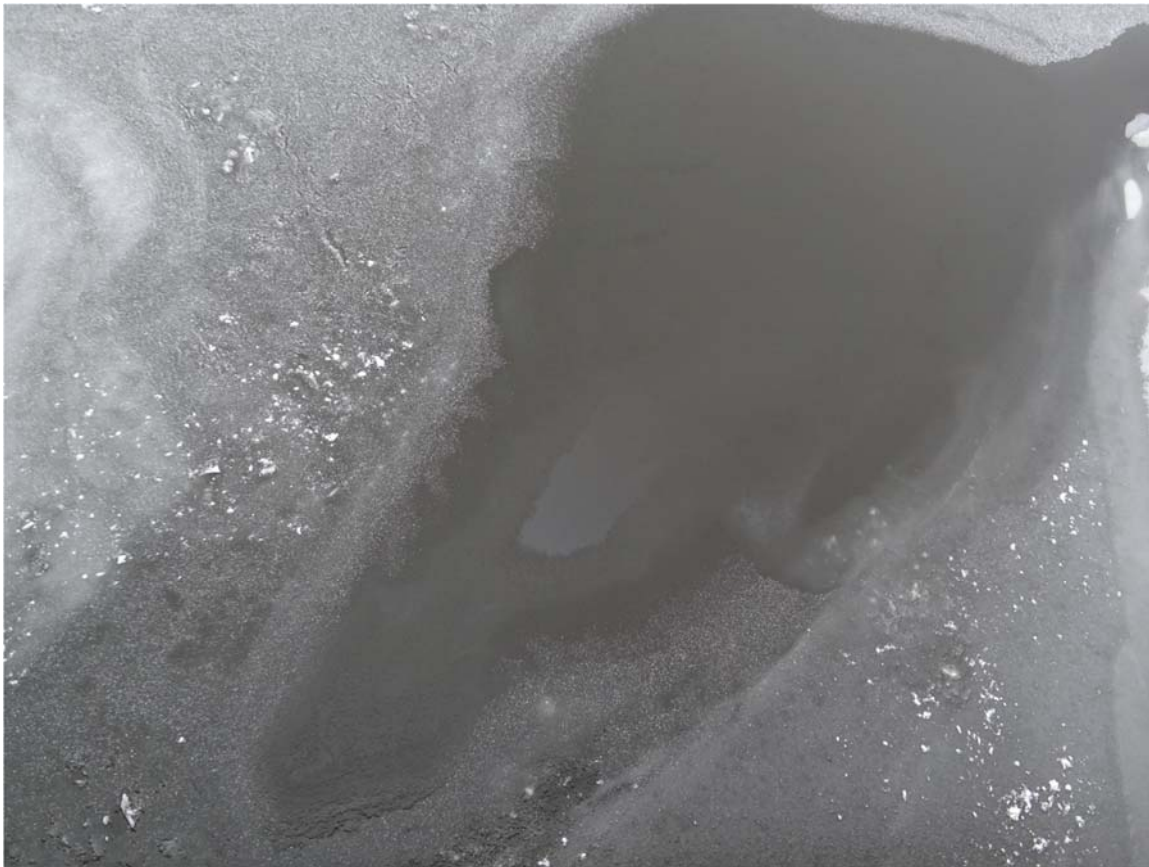
11. MP21.5 Sheen observed in a pocket of melted ice.

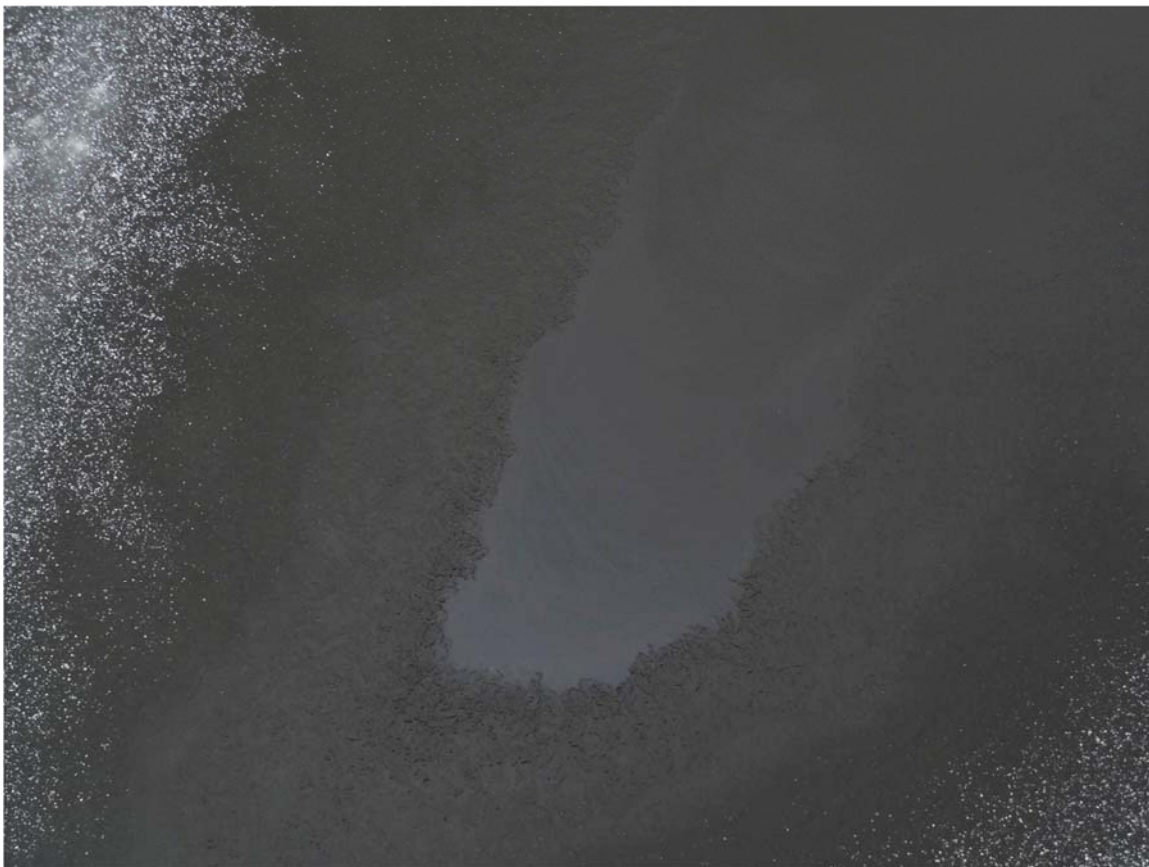
12. MP21.5 Sheen observed in a pocket of melted ice.

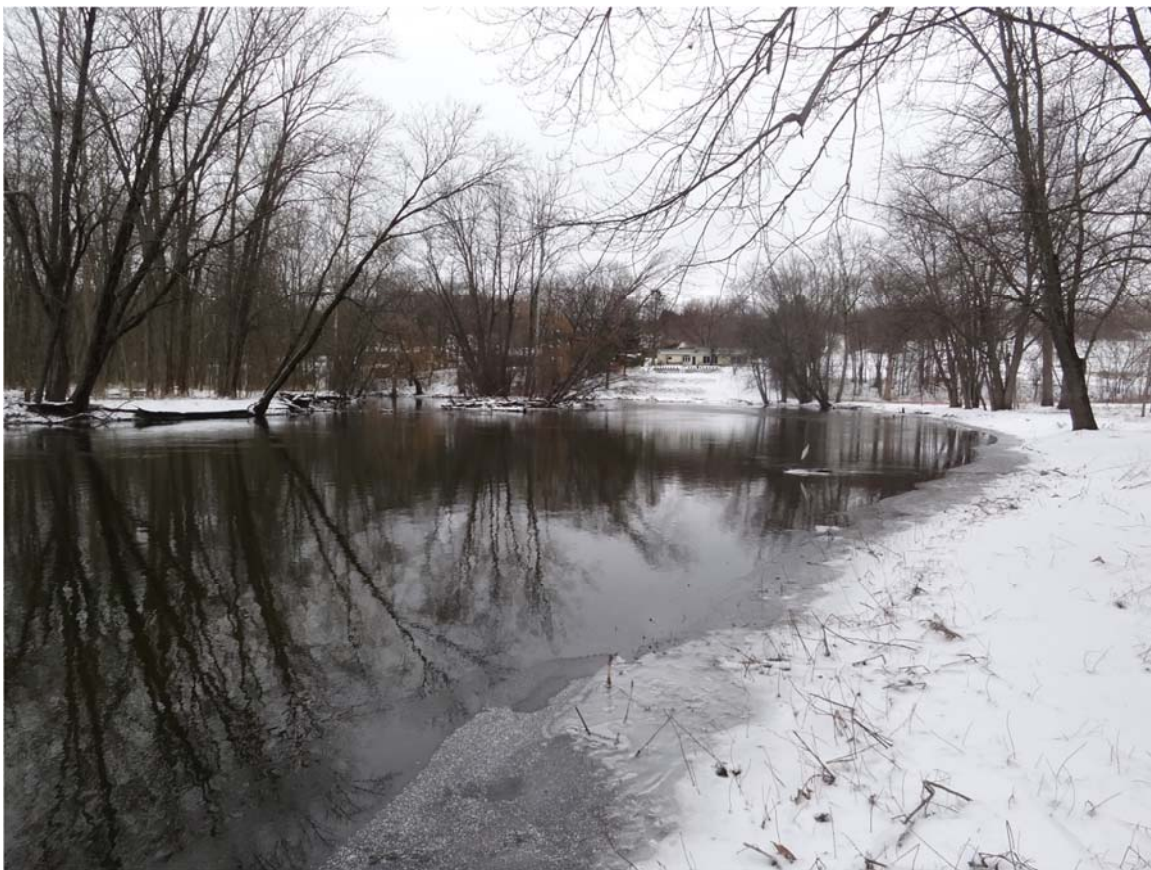
13. MP27.0 Shady Bend Campground river conditions observed.

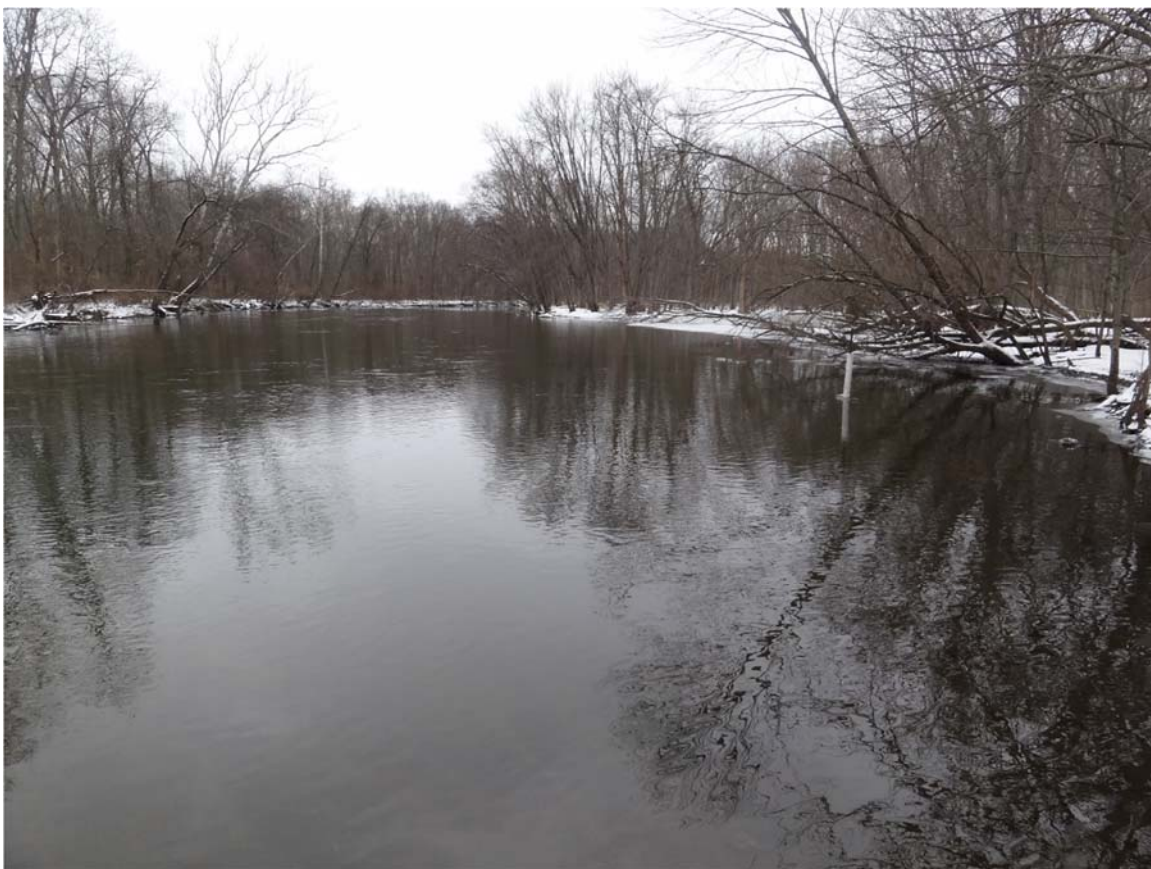
14. E2 Boat launch observed river conditions.

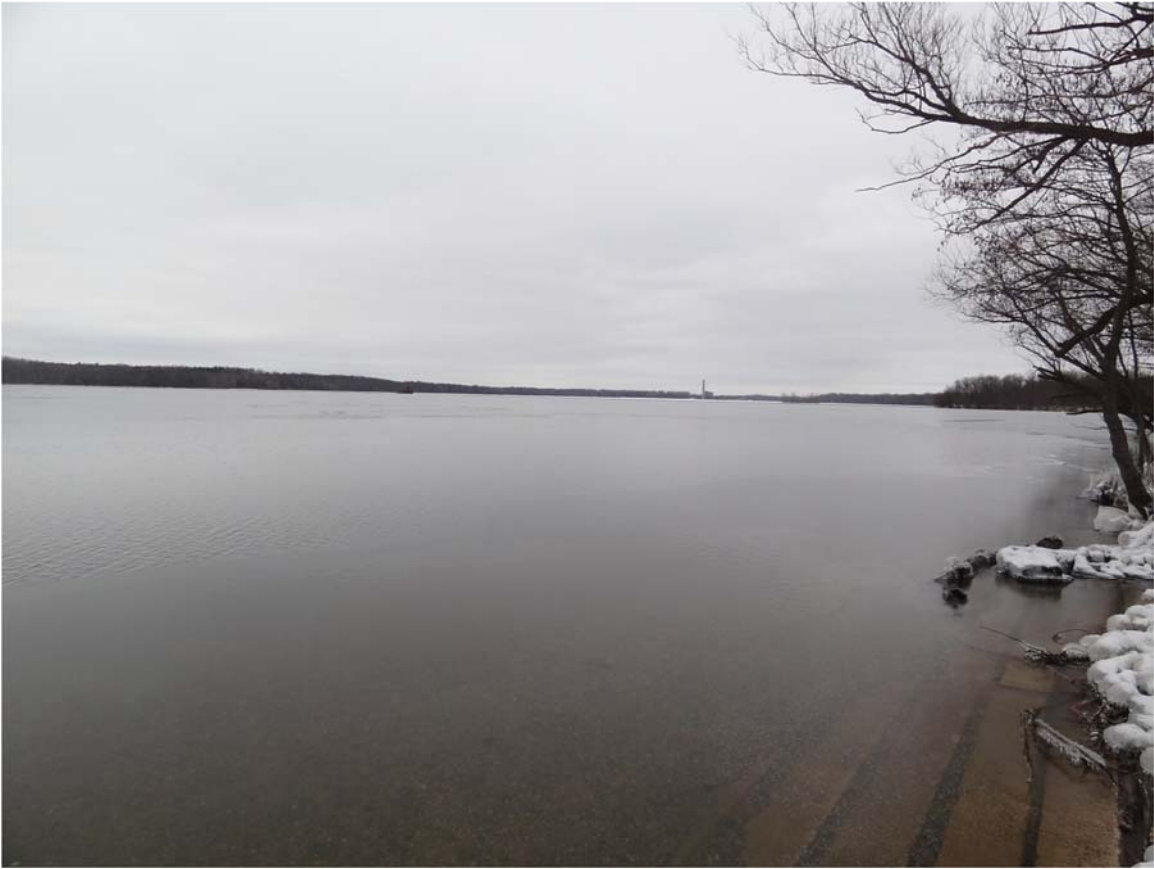
15. Morrow Lake icing conditions observed.

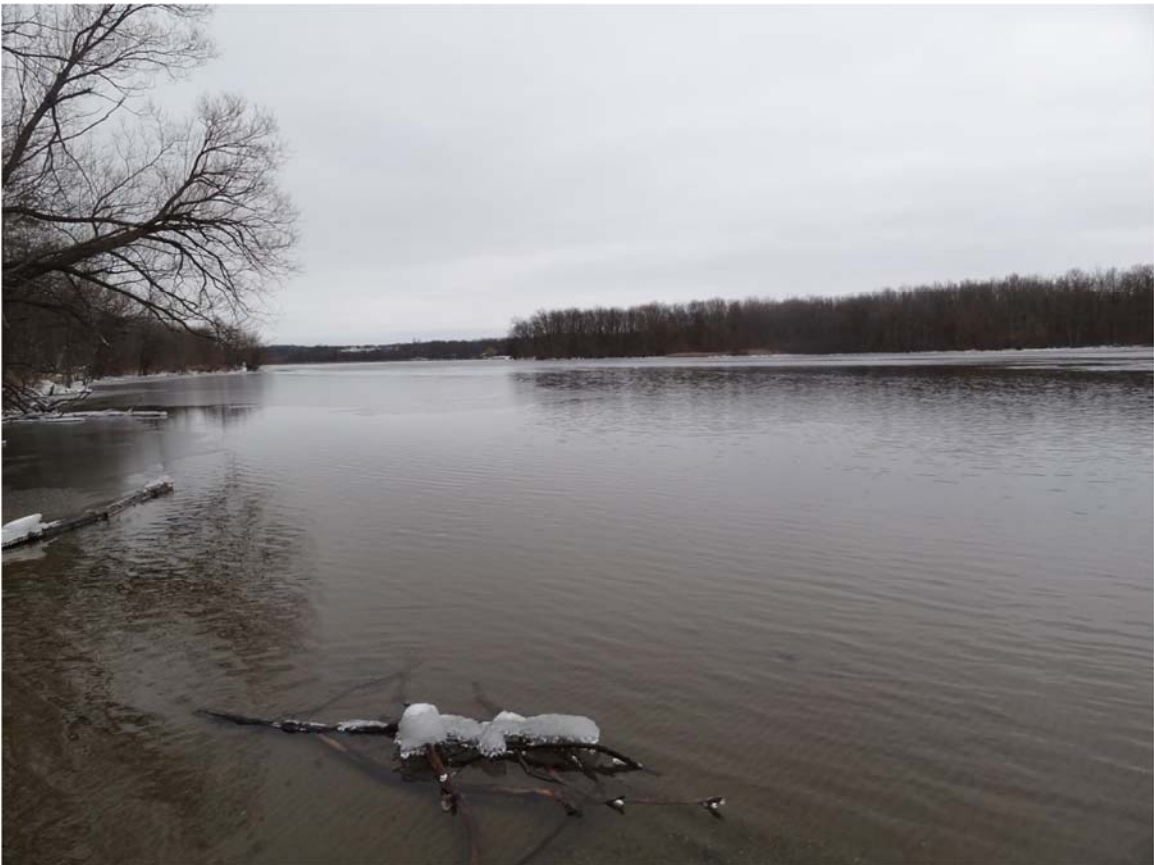
16. Morrow Lake Delta Neck river icing conditions observed.

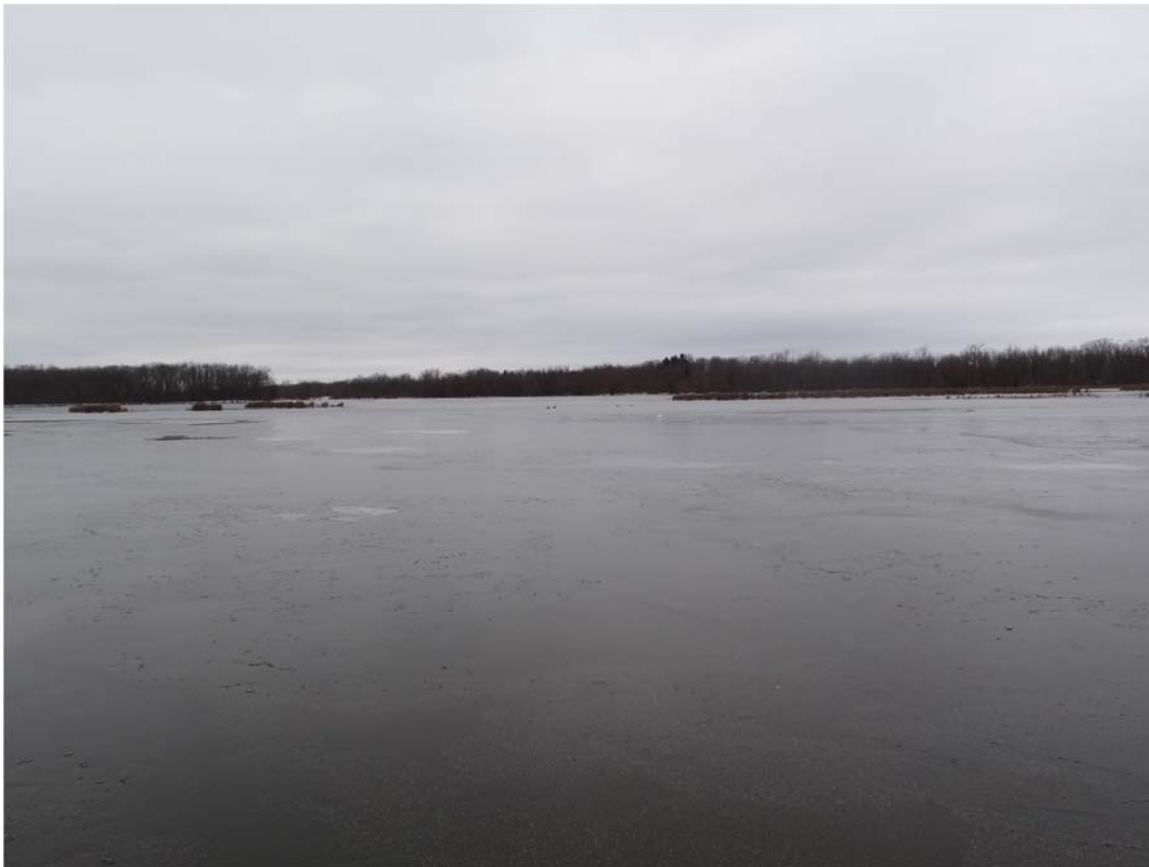
17. Morrow Lake Delta river icing conditions observed.

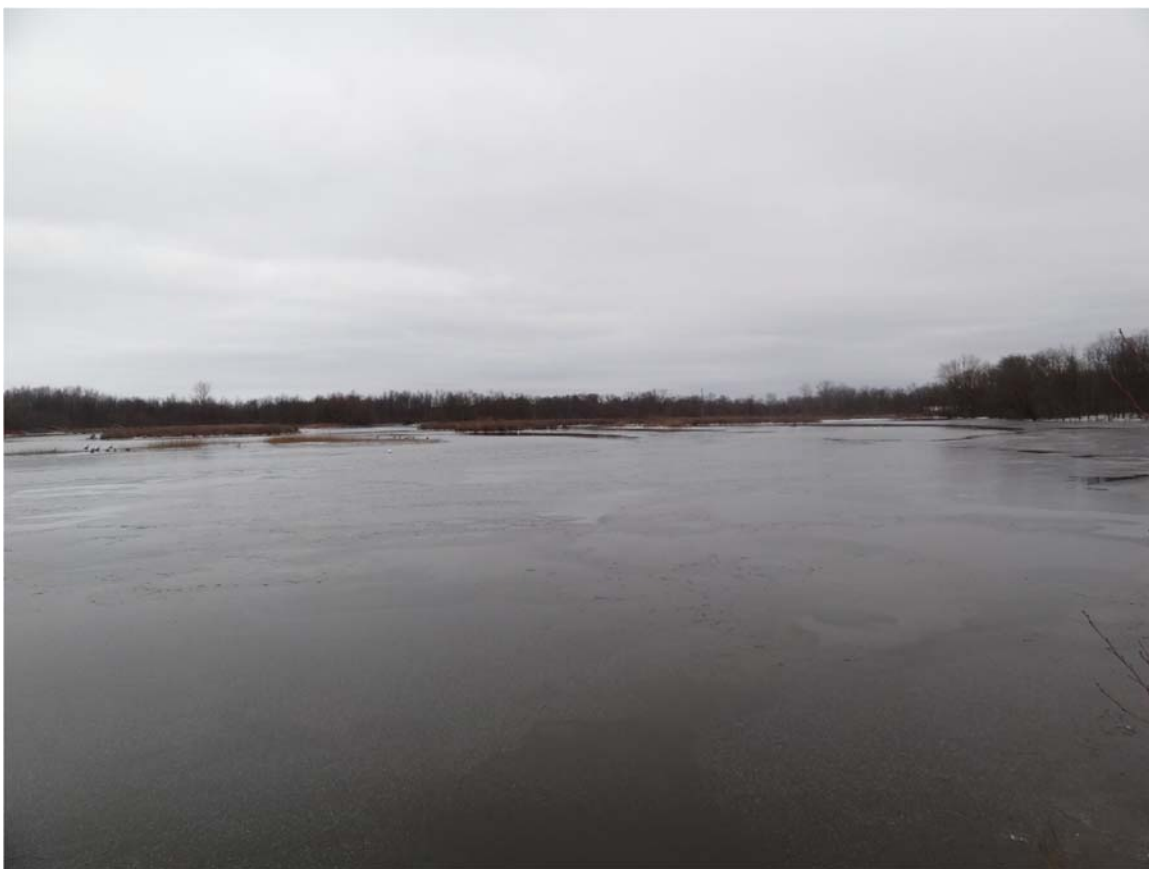
18. Morrow Lake Delta river icing conditions observed.

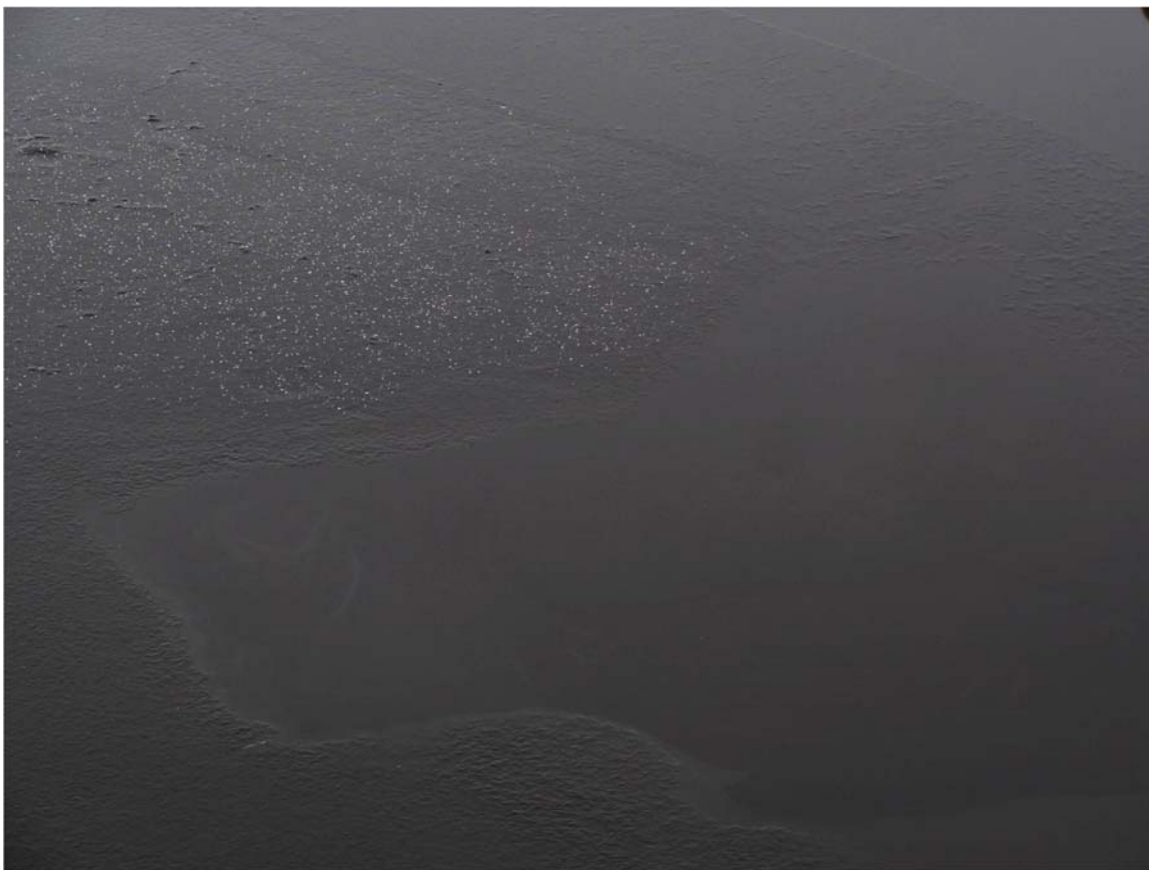
19. Morrow Lake Delta sheen observed in a pool of melted ice.

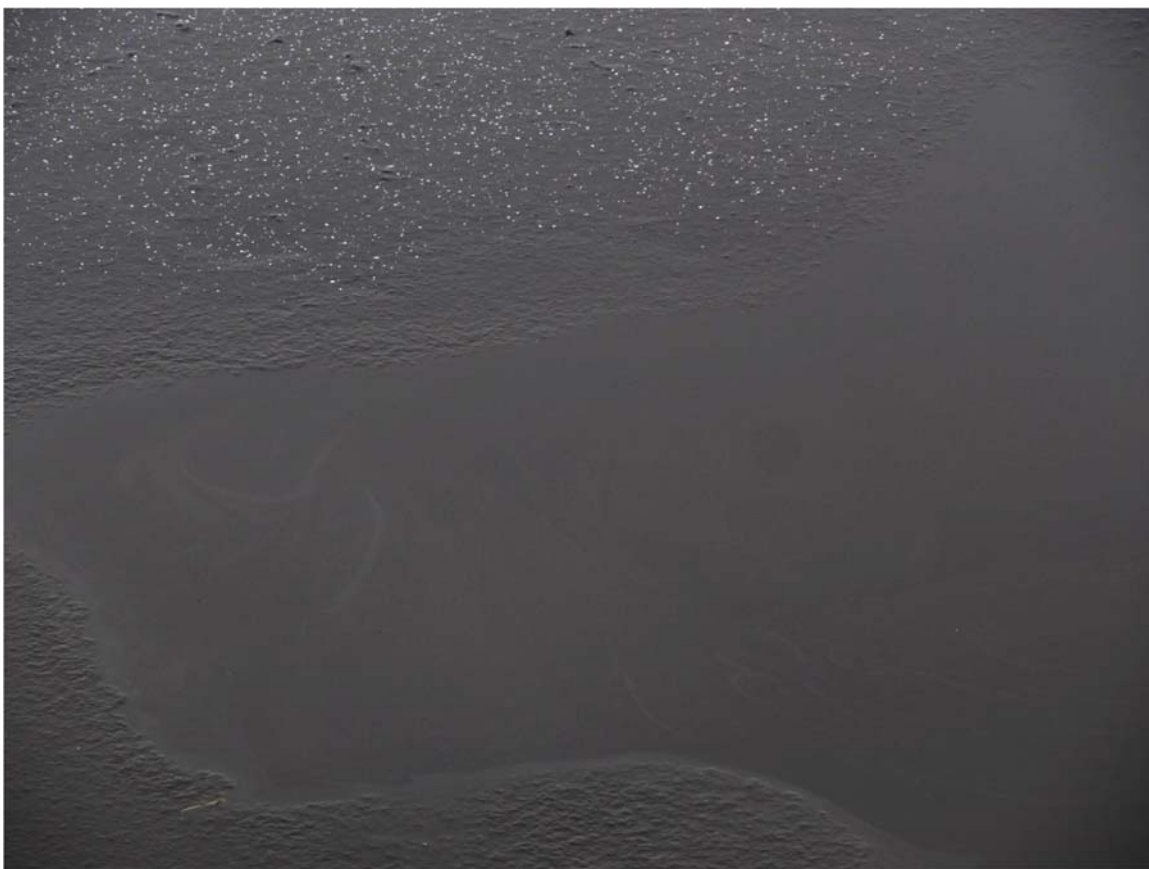
20. Morrow Lake Delta sheen observed in a pool of melted ice.
